NSWC/DL-TR-3904

4. TITLE (and Subtitle) FABRICATION AND ASSEMBLY OF A SHIPBOARD MULTI-FUNCTIONAL WASTE INCINERATOR (MFI). PHASE II	5. TYPE OF REPORT & PERIOD COVERED Final rept.

7. AUTHOR(s) F. Crowson, J. A. Byrne W. W. Jones	8. CONTRACT OR GRANT NUMBER(s)	
9. PERFORMING ORGANIZATION NAME AND ADDRESS Naval Surface Weapons Center (G51) Dahlgren Laboratory Dahlgren, VA 22448	10. PROGRAM ELEMENT, PROJECT, TASK AREA & WORK UNIT NUMBERS NAVSEA WR N0002478: WR 8G140: CG43KE3

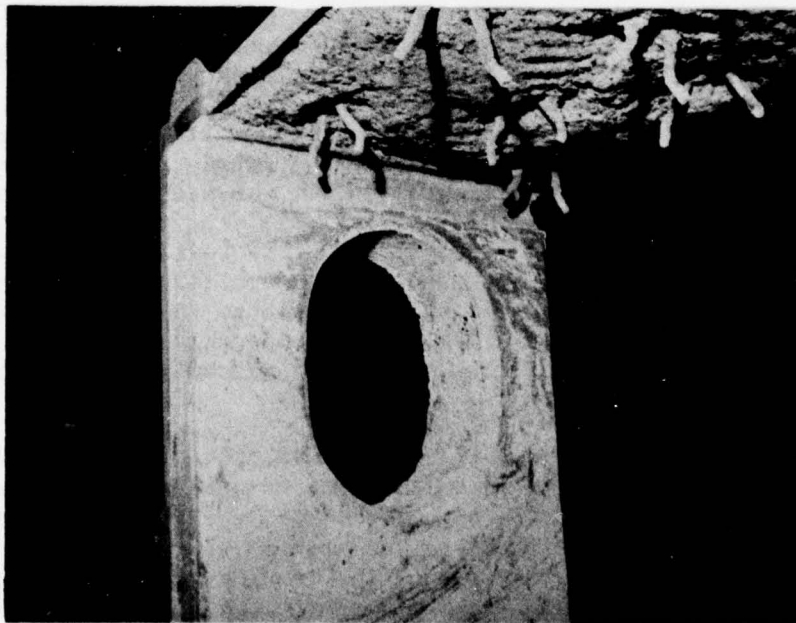
Figure 7. Sewage Chamber Casting

Figure 7 shows the sewage chamber walls: one wall partially cast, and the other wall completely cast. The oval-shaped exhaust port can be observed on the fully cast wall. The cast firebox module was assembled as shown in Figure 8 to check for alignment. The forward wall, the right (burner) side wall, and the rear wall are shown in position. The left side panel cracked diagonally when alignment pins were used to align bolt holes. The panel was recast within 2 hr and after curing, was refit to the module. A small crack about 6 in. in length occurred again upon assembly across the upper right corner. This crack was small enough to be patched with Greencast 97 fines.

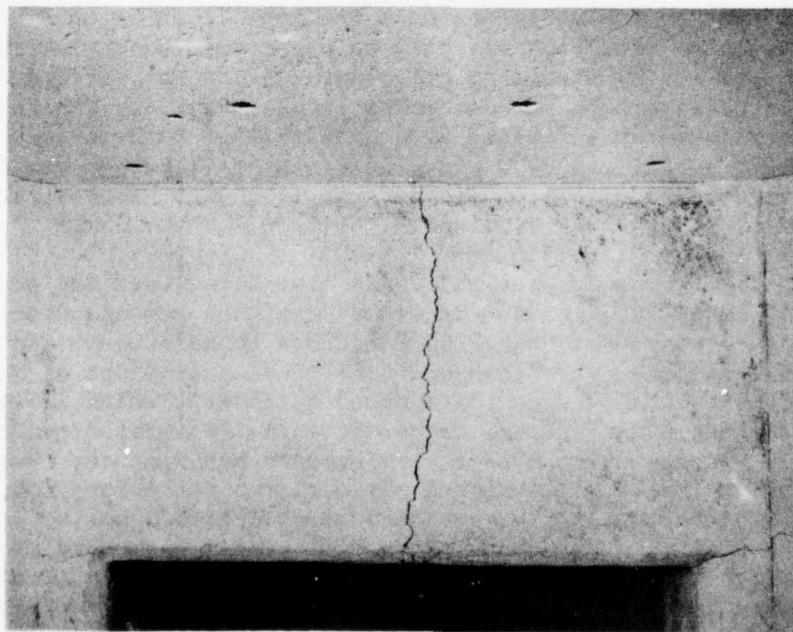
Figure 28. Cracking in Front Wall of Firebox After Curing

Upon completion of the 88-hr cure period, photodocumentation was again made of the incinerator interior. Figures 29 through 36 show the cracking of the refractory. Several cracks not exceeding 1/16-in. in width were observed primarily above the feed door and in the sewage chamber roof panel. Very minute hairline cracking was observed in the two extra tops (Figures 37 and 38). Figure 37 shows the top cast using NAVSEC Philadelphia design sliding anchors; and Figure 38 shows the top (identical with the top construction on the incinerator) cast with the standard A. P. Green SS anchors.

Thermal stresses must be minimized to reduce severity of cracking in the Greencast 97 refractory. Additionally, uncured refractory must be handled with extreme care to prevent cracks from mechanical shocks and strains.

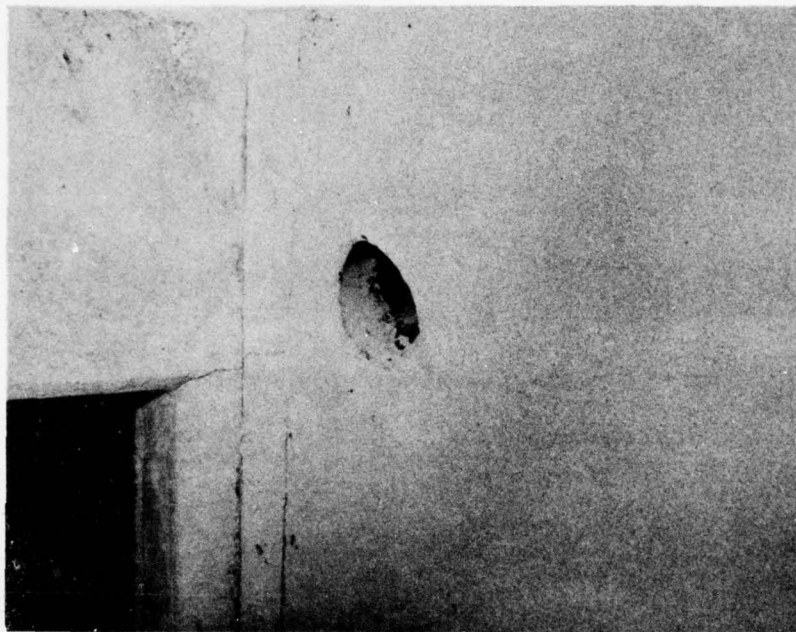
Figure 29. Left Interior Wall of Firebox After Curing

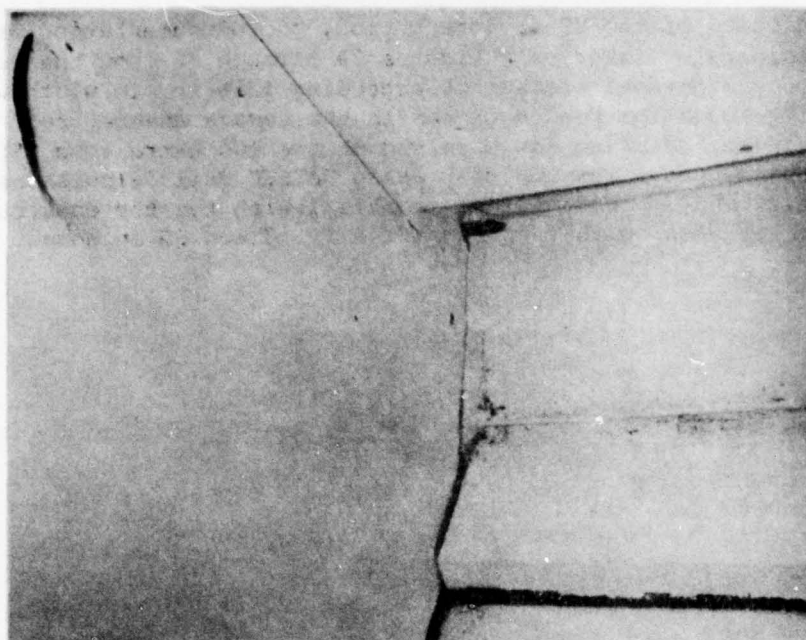
Figure 30. Ash Drawer Assembly After Curing

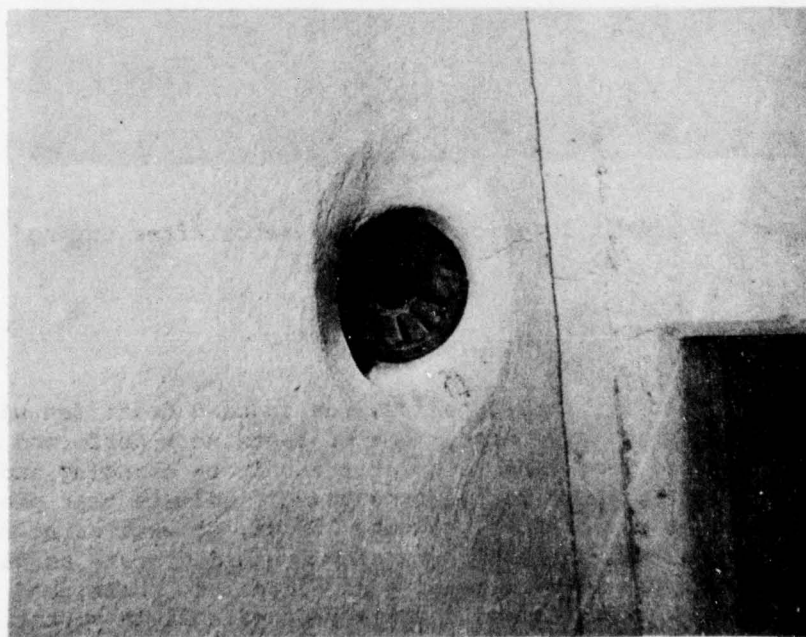
Figure 31. Right (Burner Side) Interior Wall of Firebox After Curing

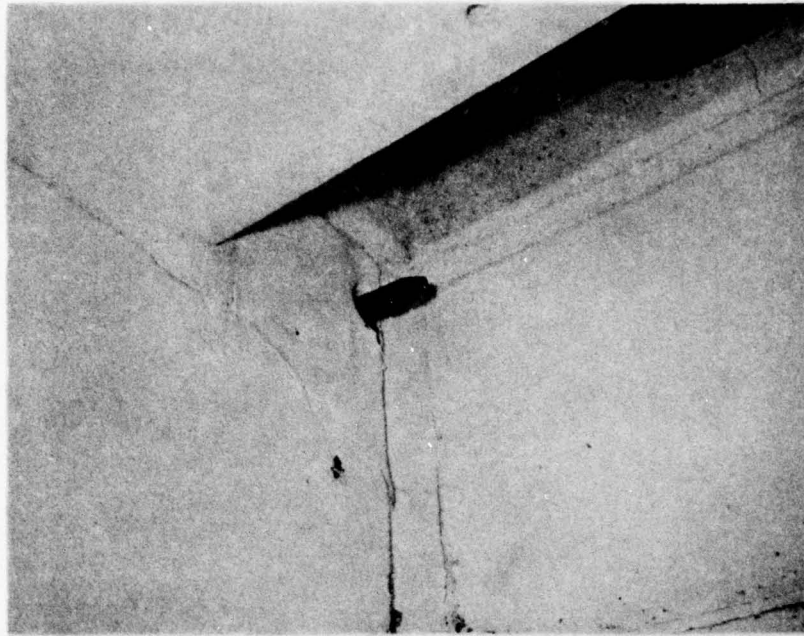
Figure 32. Entrance to Sewage Chamber After Curing

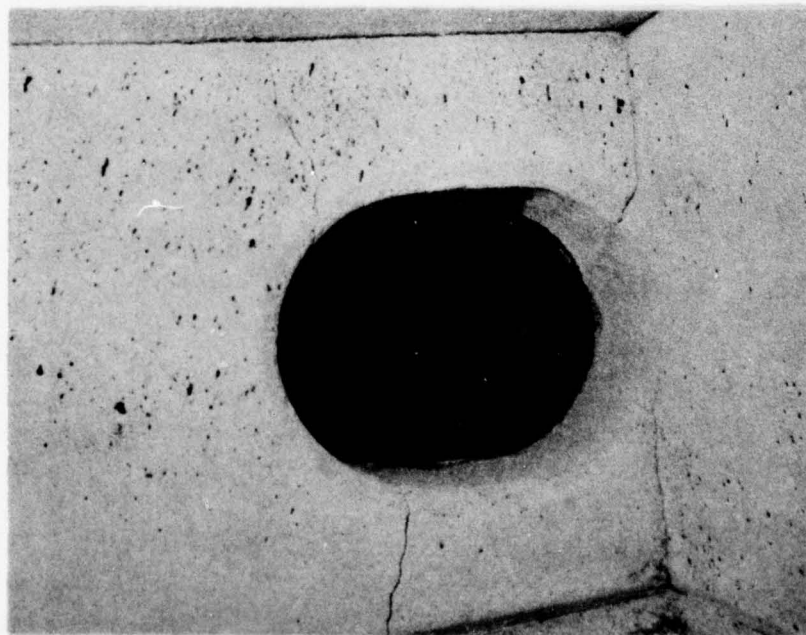
Figure 33. Sewage Chamber Access Port After Curing

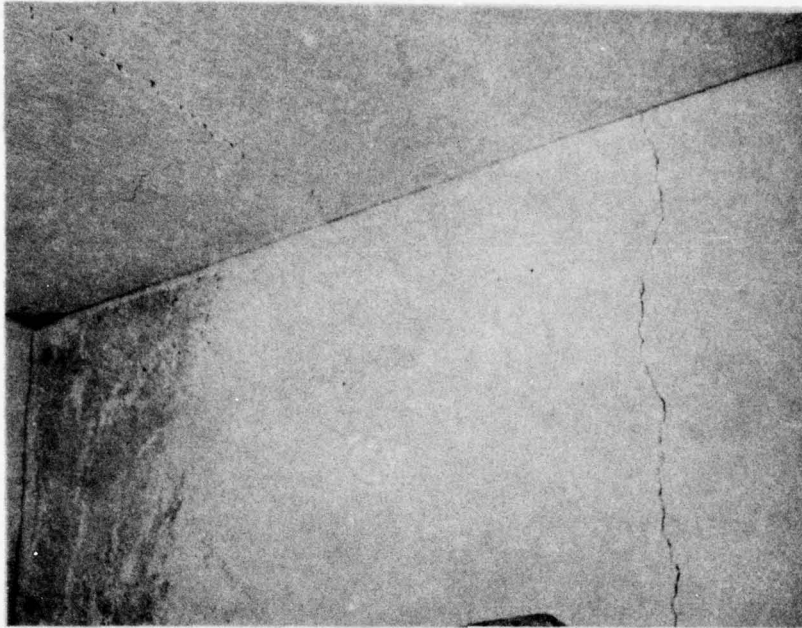
Figure 34. Right Wall of Sewage Chamber After Curing

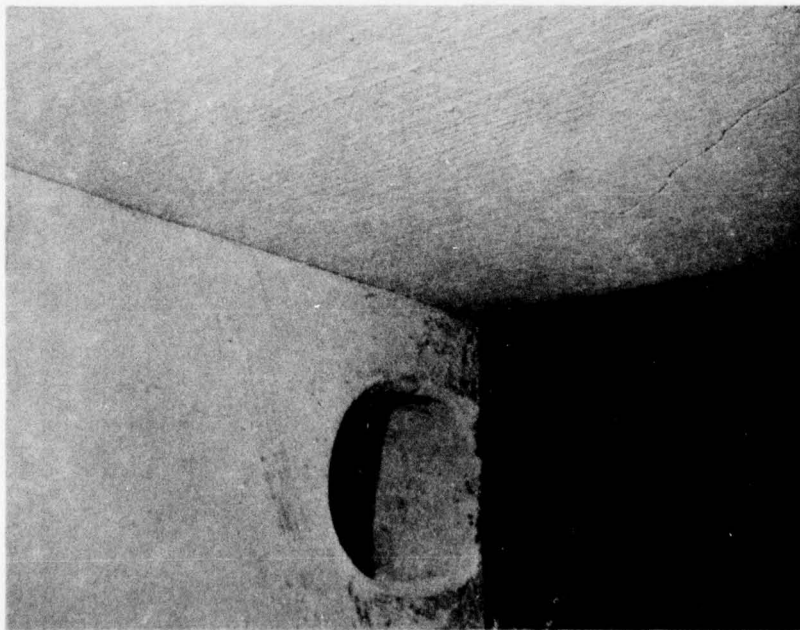
Figure 35. Jade Pak on Rear Wall of Sewage Chamber After Curing

In-situ curing of the Jade Pak 88 plastic refractory to 2200°F in a fully assembled unit is not possible with the current equipment. If the present cure is insufficient for maximum material strength, future assemblies will have to incorporate pre-cured castings properly interlocked with other refractory materials.

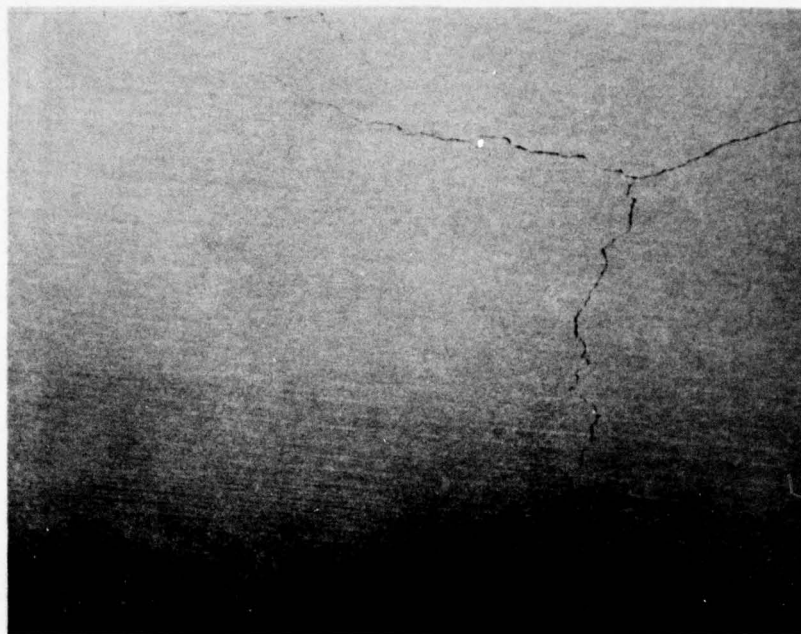
Figure 36. Sewage Chamber Roof Panel After Curing

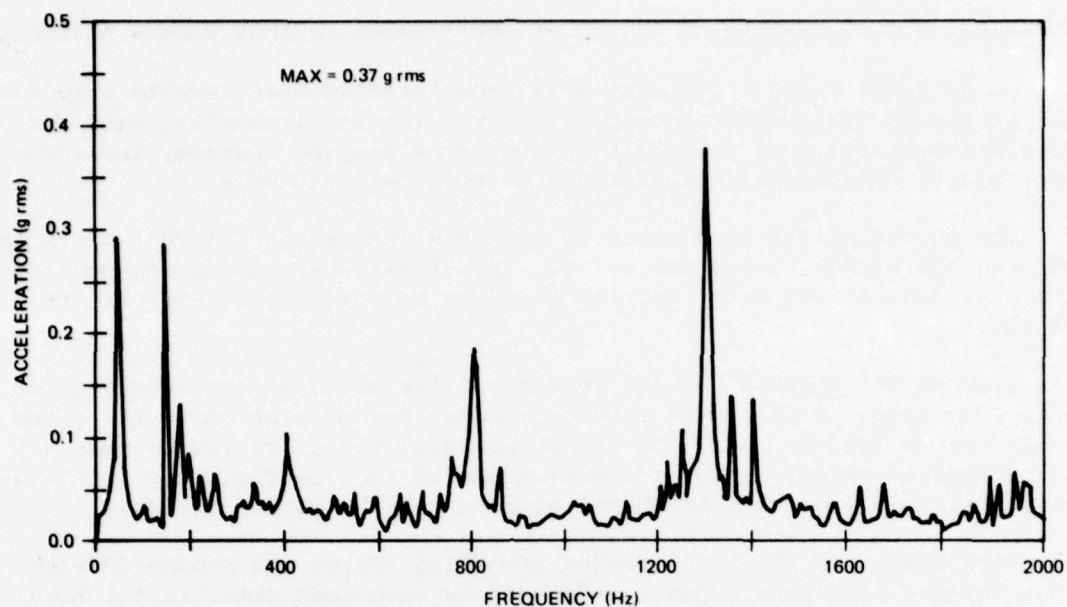
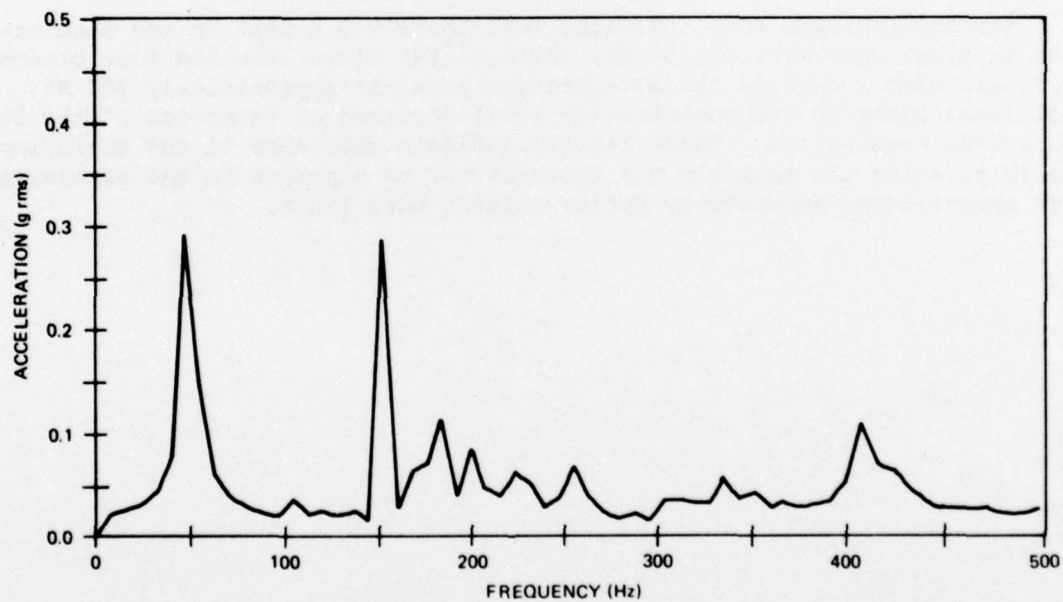
Figure C-1. Acceleration on Bearing Housing With Only the Blower Operating

The acceleration data indicated that there was a peak in the acceleration level at approximately 50 Hz. Because the blower fan had four blades, there was also a peak in the acceleration level at approximately 200 Hz. Additional peaks in the acceleration level occurred at harmonics of the 50- and 200-Hz frequencies. These results indicate unbalance in the shaft/impeller assembly, which was possibly due to shaft set on exposure to the excessively high temperatures encountered during initial burn tests.

NOTE: THE OVERALL g LEVEL WAS 2.55 g PEAK (1.8 g rms)

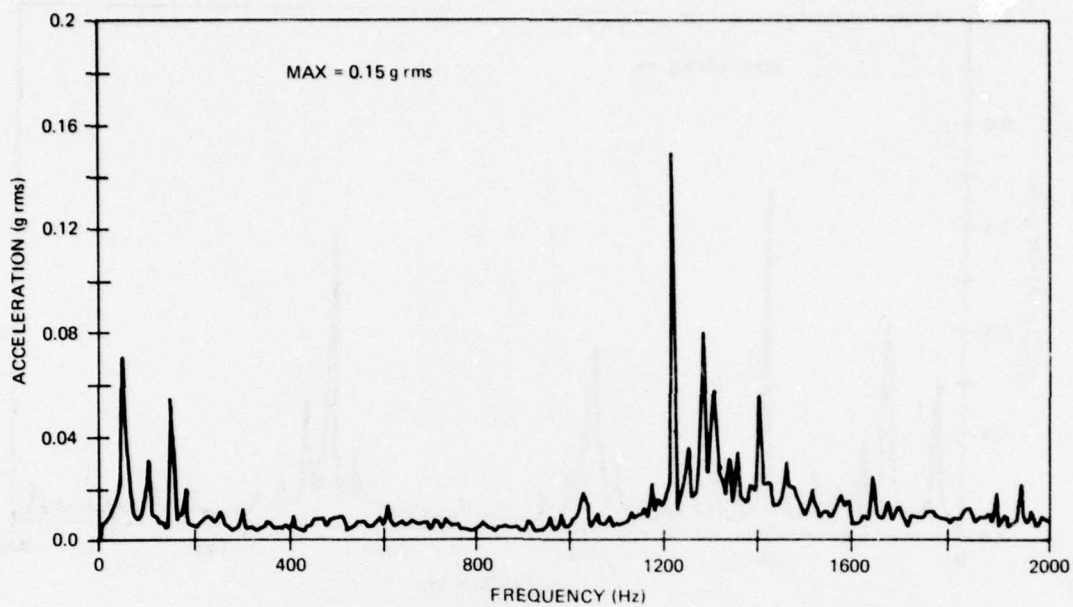
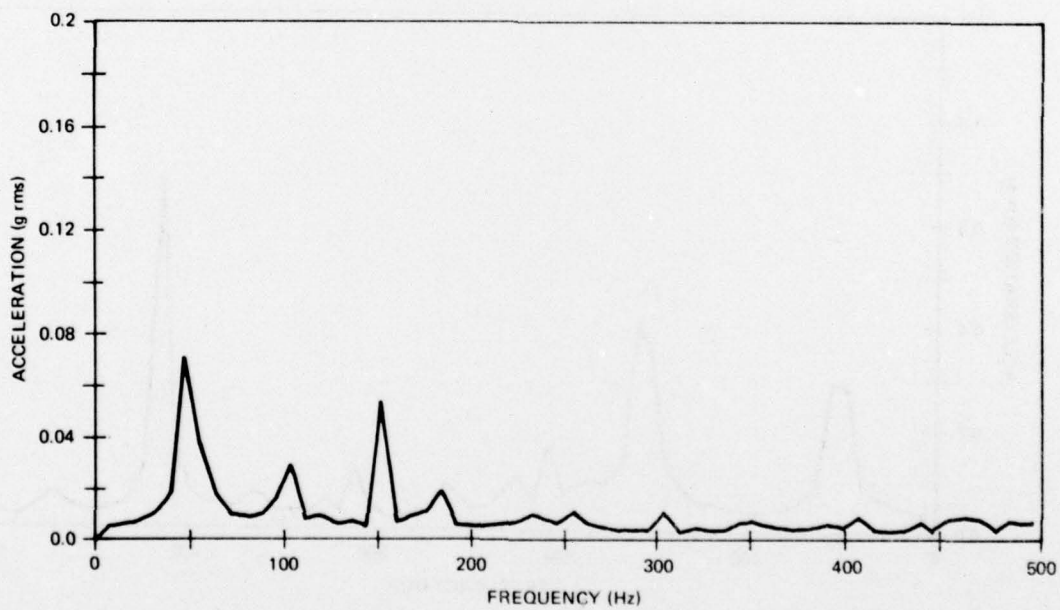
Figure C-2. Acceleration on Right Front Motor Mount  
With Only the Blower Operating

NOTE: THE OVERALL g LEVEL WAS 0.4 g PEAK (0.28 g rms)

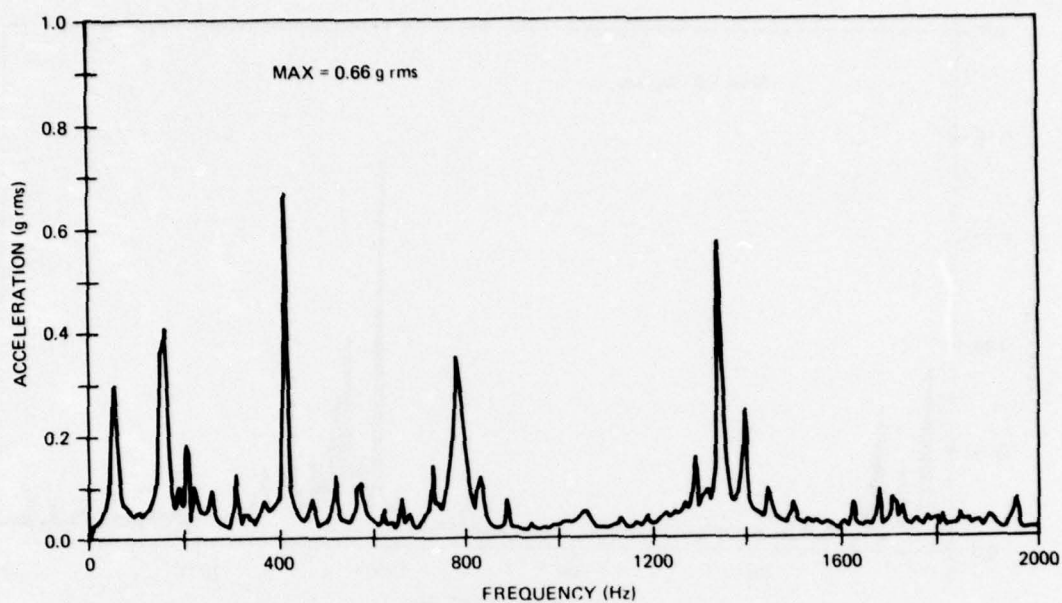
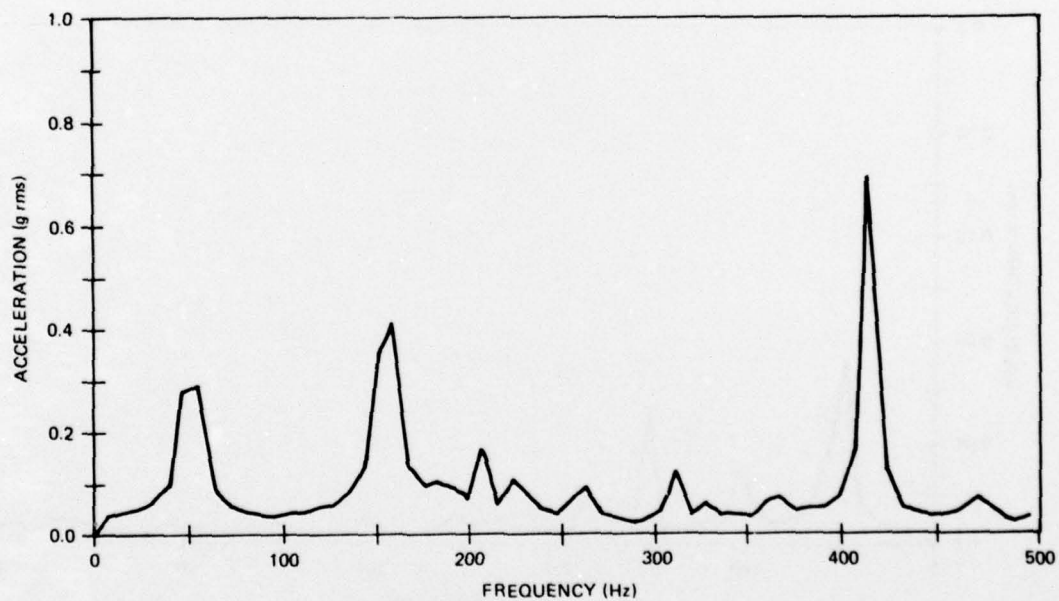
Figure C-3. Acceleration on the Bearing Housing With the Incinerator in Full Operation

NOTE: THE OVERALL g LEVEL WAS 3.0 g PEAK (2.12 g rms)

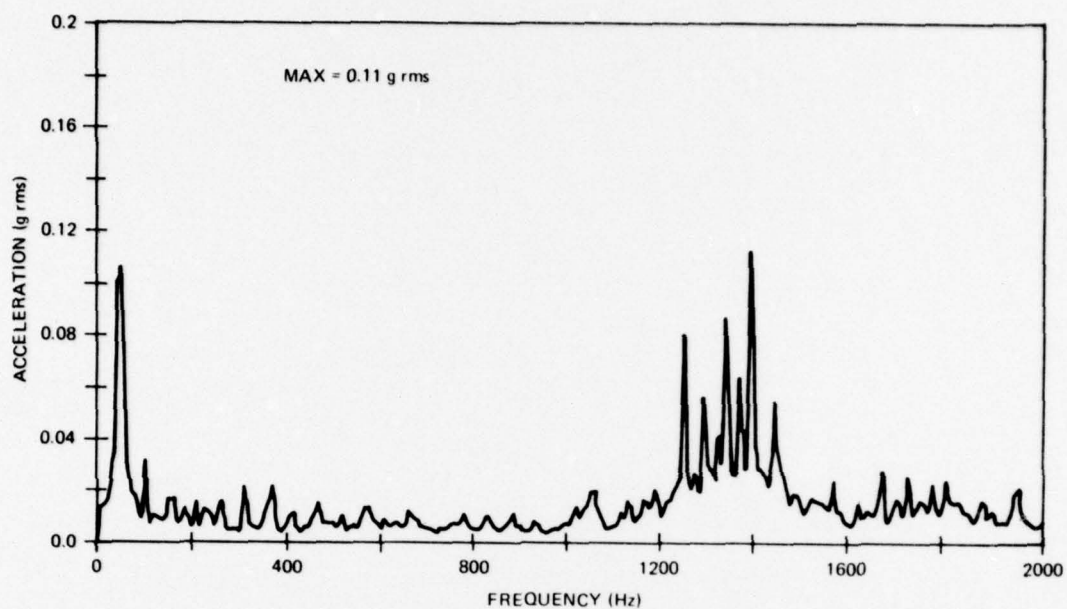
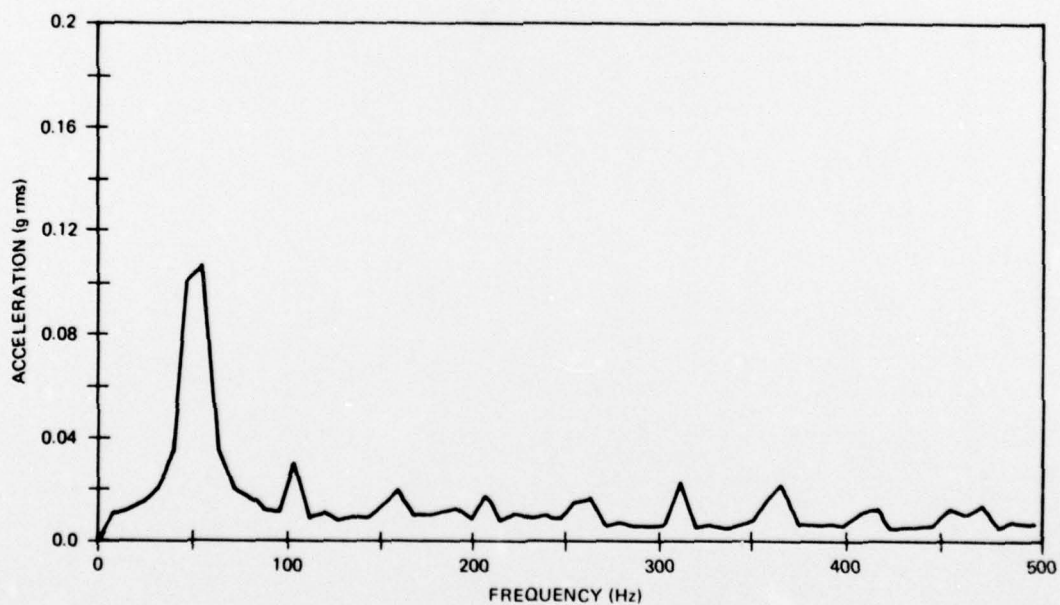
Figure C-4. Acceleration on the Right Front Motor Mount With Incinerator in Full Operation

NOTE: THE OVERALL g LEVEL WAS 0.5 g PEAK (0.35 g rms)
